Manhole Inspection Summary

Manhole # S27K__010MH

Insp Date: **6/3/08 1:18 PM**

Location Address: **817 Ramsey**

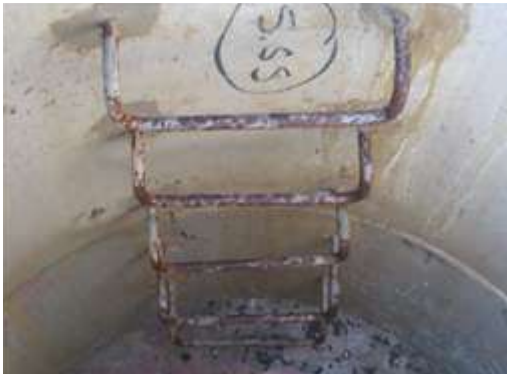
Defect 2

Count: **5** Missing: **0** ☒ **Corroded**

oxidized rungs

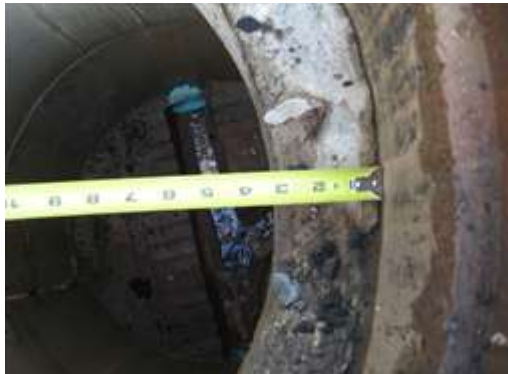
Defect 3

Offset: **3** (in.)

offset frame 3"

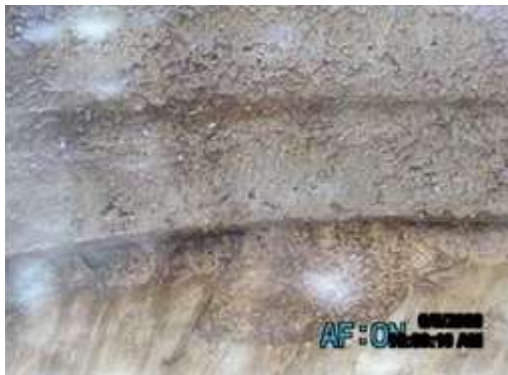
Defect 1

☒ **Leaks**

infiltration lid frame

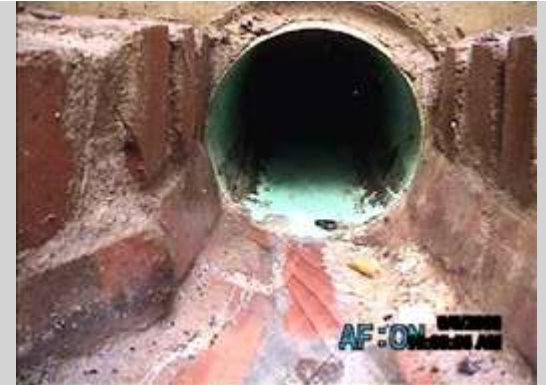
12 O'Clock Outflow

8 in. Circular Gravity Sewer
Pipe Out @ 12 O'Clock

Pipe Height: **8.4** (in.) Rod and Bar (Angled)
Pipe Material: **PVC** ☐ Pipe Lined
Invert Depth: **7.63** (ft.) Flow Characteristics: **Fast**
Deposits: ☒ None ☐ Mud ☐ Sludge ☐ Debris ☐ Grease
Silt Depth: **0** (in.) Deposits Extent:
Infiltration: **None** Pipe Seal Cond: **Sound**

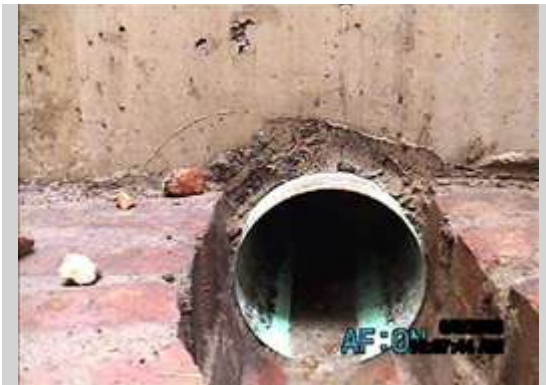
6 O'Clock Inflow

8 in. Circular Gravity Sewer
Pipe In @ 6 O'Clock

Pipe Height: **8.4** (in.) Rod and Bar (Angled)
Pipe Material: **PVC** ☐ Pipe Lined
Invert Depth: **7.52** (ft.) Flow Characteristics: **Slow**
Deposits: ☒ None ☐ Mud ☐ Sludge ☐ Debris ☐ Grease
Silt Depth: **0** (in.) Deposits Extent:
Infiltration: **None** Pipe Seal Cond: **Sound**

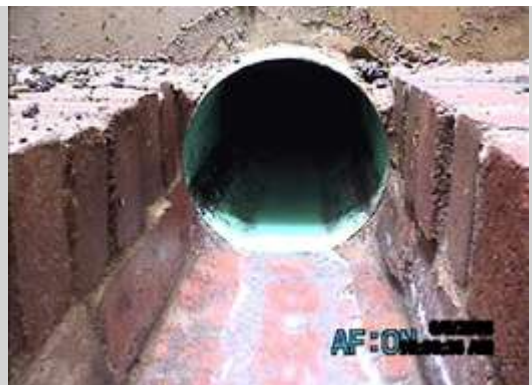
9 O'Clock Inflow

8 in. Circular Gravity Sewer
Pipe In @ 9 O'Clock

Infiltration: **None** Pipe Seal Cond: **Sound**
